**GEOTECHNICAL INFRASTRUCTURE ASSET
MANAGEMENT FOCUSING ON
PERFORMANCE DETERIORATION PROCESS
OF GROUND ANCHORS**

A thesis submitted in partial fulfillment of the requirements for the
degree of Doctor of Engineering

Department of Urban Management,
Graduate School of Engineering,
Kyoto University
Japan

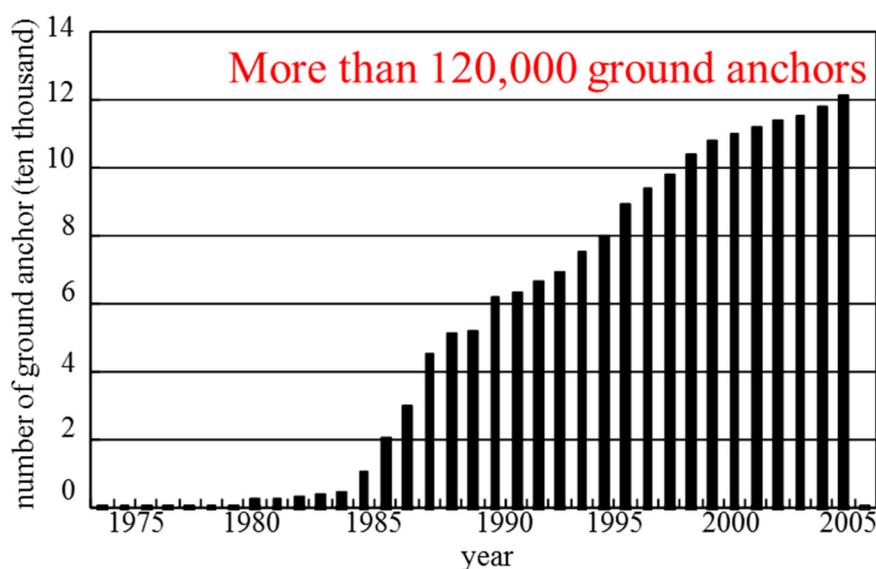
Figure 1.1 Total number of ground anchor used in Japan since 1970 (Miyatake et al, 2007)

Forty years since the first ground anchor was installed in western Japan; ground anchors have been employed for various purposes, more than 120,000 ground anchors in at least 30,000 projects (see Fig 1.1) Some of them constructed in earlier times have aged and deteriorated their performance, such as lost in pre-stresses force, resulting in slope deformation and exposure of broken anchor heads (Miyatake et al, 2007). The deterioration of ground anchors indicated the reduction on quality or strength with time as a result of fatigue and collusion, multiple aggressive environment factor, poor workmanship, inadequate design and lack of maintenance (Ohtsu, 2011). Therefore, it is necessary to predict the deterioration rate of ground anchor quantitatively, and to do the strategic maintenance from the viewpoint of the asset management (Kimoto et al, 2011).

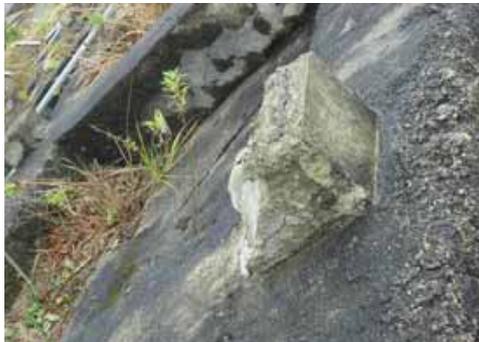
(a) Ground anchor head broke

Figure 1.2 illustrate the example of ground anchors deterioration in several modes. Some of them showed concrete head broken, which increasing rusting on the tendon bar or wire as demonstrated in Fig 1.2 (a). Generally, after time gone by, rust might occur on the tendon bar or wire, it directly affected to force in the ground anchors since load depending on the cross-section area of the tendon bar (see Fig 1.2 (b)). Moreover, no remaining force on several ground anchors because a tendon bar might be broken due to over-stresses or heavily corroded on the tendon bar as illustrated in Fig 1.2 (c). Finally, concrete cover on slope might crack due to over-deformation (see Figure 1.2 (d)), then slopes danger to collapse in the near future.

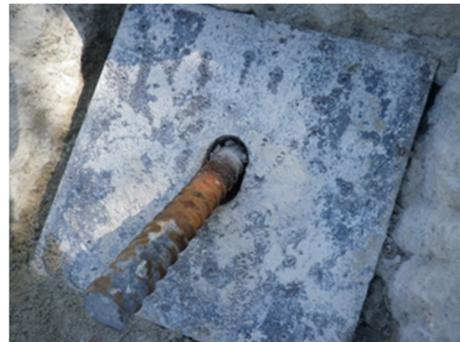
(b) Rust on the ground anchor (rod type)

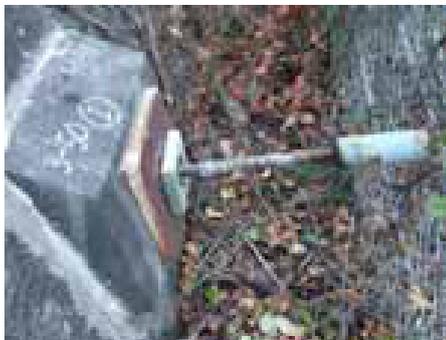
(c) No existing force in anchor

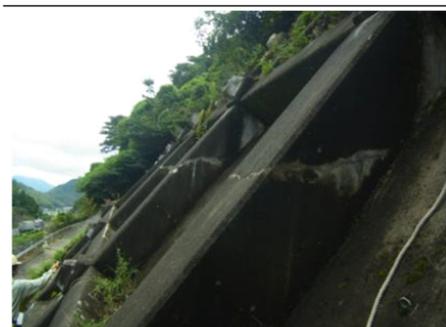
(d) Crack on the concrete

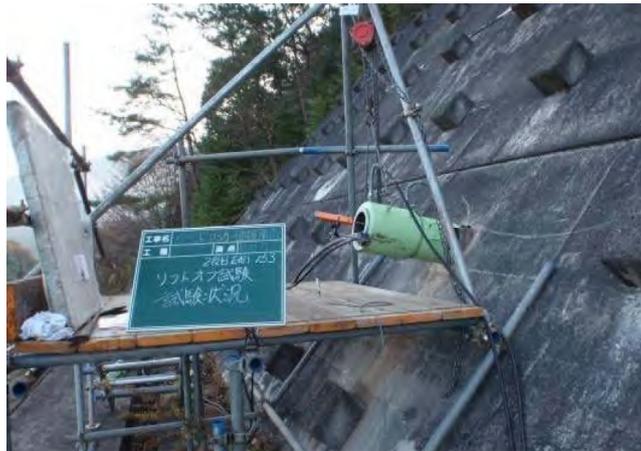
(a) Schematic of the Lift-off test

The Lift-off test provided the existing force to verify the capability of ground anchors. It was adopted as the direct method to measure residual force as well as the abnormality of bonding and tendon portions. However, the cost of the lift-off testing is more expensive than the visual inspection test; moreover, the lift-off test is also difficult to test, because it takes longer time for setting up equipment and platform while the visual inspection test is an only observation on the head of ground anchor with a lightweight equipment. In contrast, life-off test will give more accuracy.

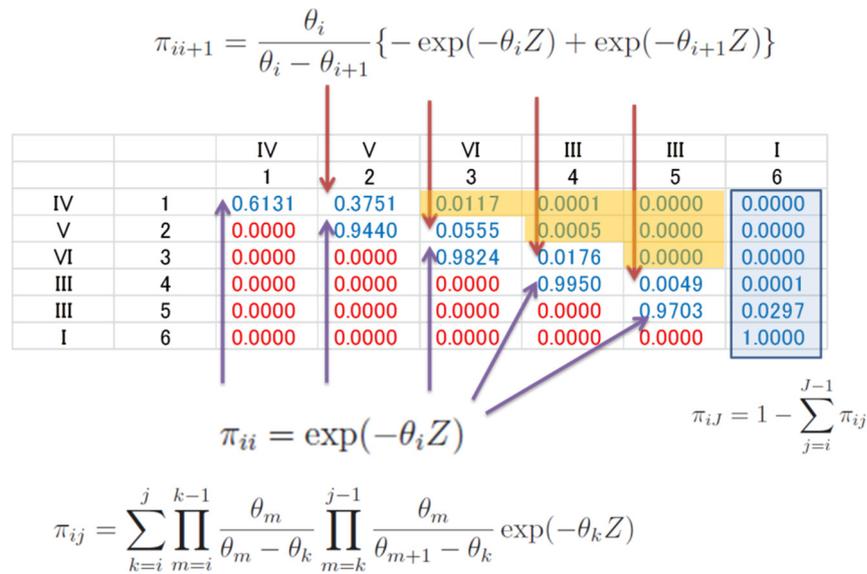
Figure 2.6 Markov hazard transition matrix calculated by MS excel

In addition, the well know commercial software, namely *MS excel* was used to calculate the Markov hazard transition matrix as shown in Fig 2.6 following Eq (2.16) to (19), respectively.

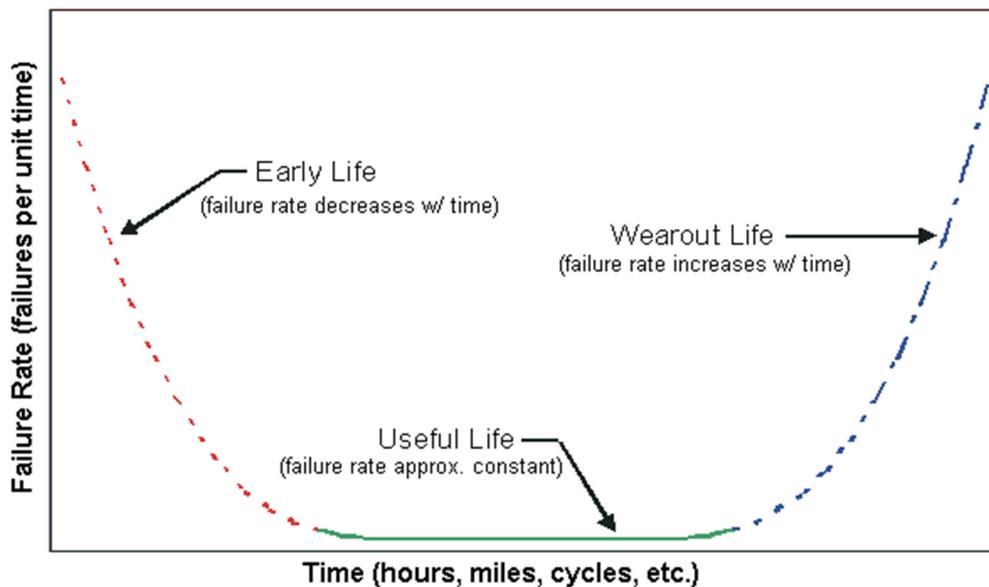
Figure 2.7 The effect of m on failure rate of Weibull hazard model

Figure 2.7 demonstrates the effect of m value on the failure rate of the Weibull hazard model. The high failure rate was found in the early stage sometime call infant failure, then the failure rate decreases continuously to the useful life that mostly seem to be constant. Finally, the failure rate increased drastically in the last, which call wear-out failure.

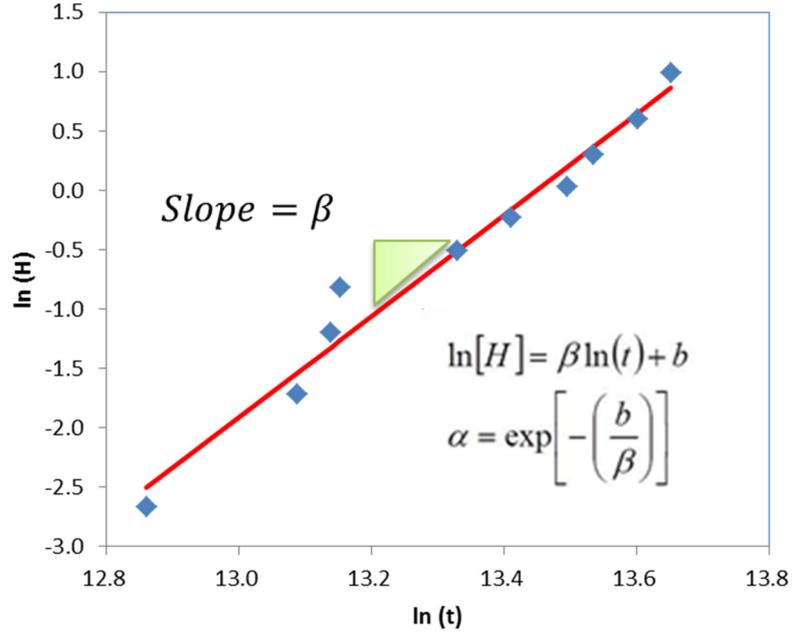
Figure 2.8 The regression curve for calculation parameters of the Weibull Hazard model

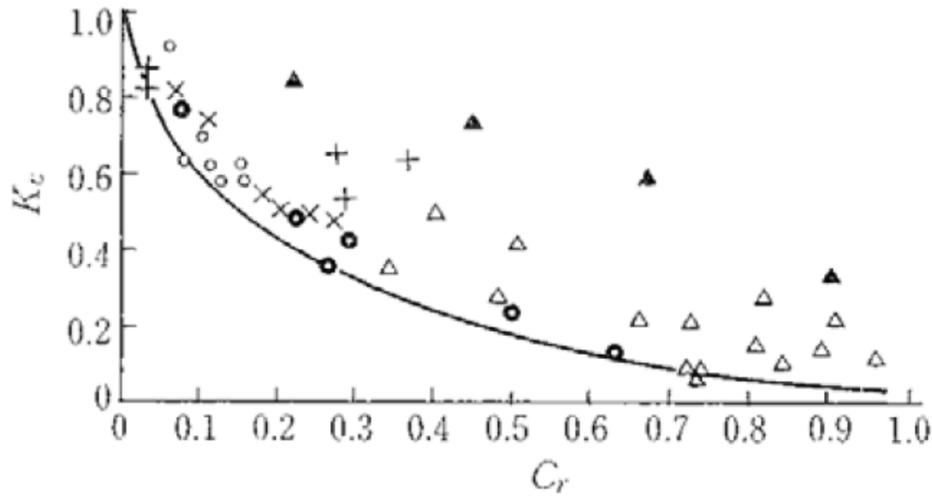
Figure 2.11 Relationship between K_c and C_r after Otani et al (2004)

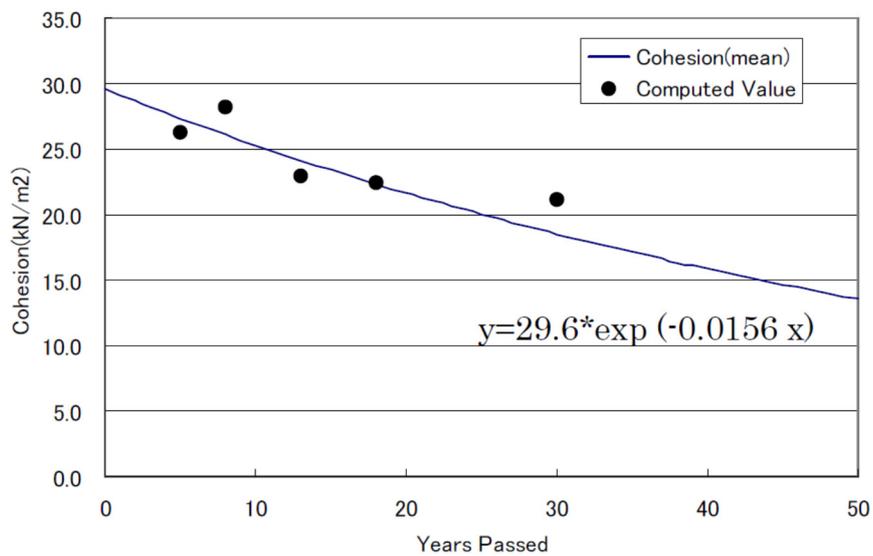
Figure 2.12 Deterioration curve of cohesion after Otani et al (2004)

Finally, calculate the trend line of cohesion deterioration rate by dealing with regression of the exponential model as demonstrated in one case study in the Fig 2.12. Figure 2.13 illustrates random path of the decrease of cohesion. It can be divided into three categories that random path whose initial value is the mean (black line), the random path whose initial is from 95% upper confidence interval (gray line) and the random path whose initial is from 95% lower confidence interval (dotted line). Generally, the drift rate of deterioration change after time gone by. Note that, the deterioration rate of internal friction angle, ϕ was neglected in this study because its quite an insignificant reduction comparing with cohesion or other word the internal friction angle, ϕ was assumed to be constant.

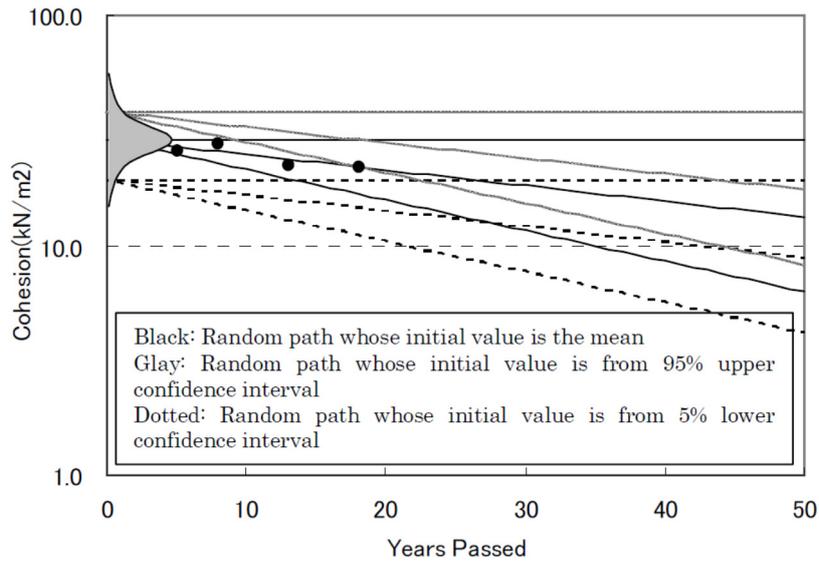
Figure 2.13 Random path of decrease of cohesion after Otani et al (2004)

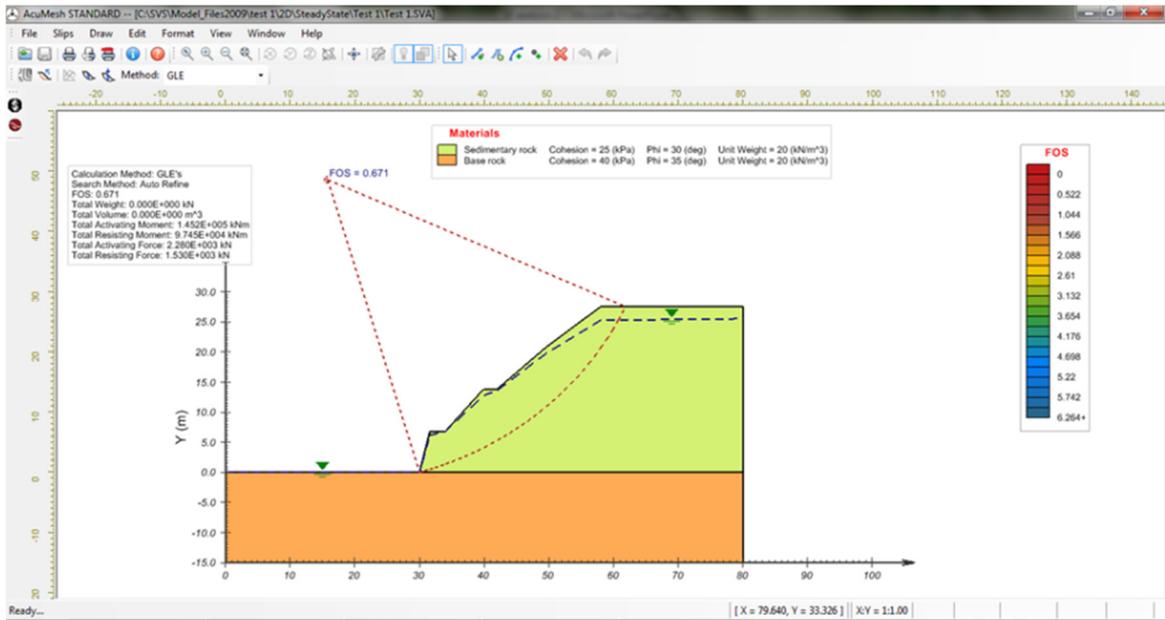
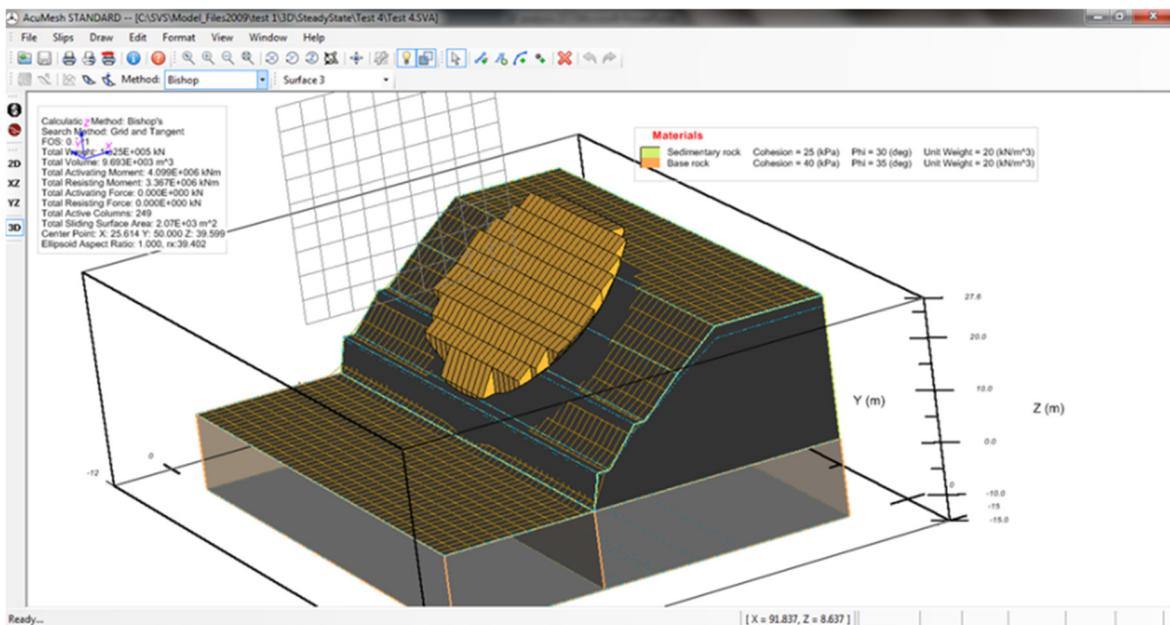
(a) Two dimensions

(b) Three dimensions

Figure 2.16 Example of slope stability analysis by *SV slope* software for circular failure pattern (a) Two dimensions and (b) Three dimensions

The commercial software, namely *SV slope* which developed by *Soil Vision Systems Ltd.* was introduced to evaluate the safety factor. Note that, the three-dimensional model was conducted in this study. The reason is it seems to be more suitable than two dimensions model because slope does not the plane strain problem. Moreover, ground anchor can be simulated as spots which more compatible with three dimension model. The mode of failure can be divided into two patterns, which are circular and plan failures as shows in Fig 2.16 and 2.17, respectively. Figure 2.16 (a) and (b) indicate the plane failure pattern which always occurs in case of high cohesion material like clay and sill slopes, whereas the plane failure pattern (see Fig 2.17 (a) and (b)) always appear on the cohesion-less slope like sand and rock. Usually, the plane failures were regularly simulated in case of rock slopes caused the orientation of rock mass controlled the location of the failure occurrence. Therefore, the plane failure pattern which more suitable for weathering rock slopes was assumed to analysis.

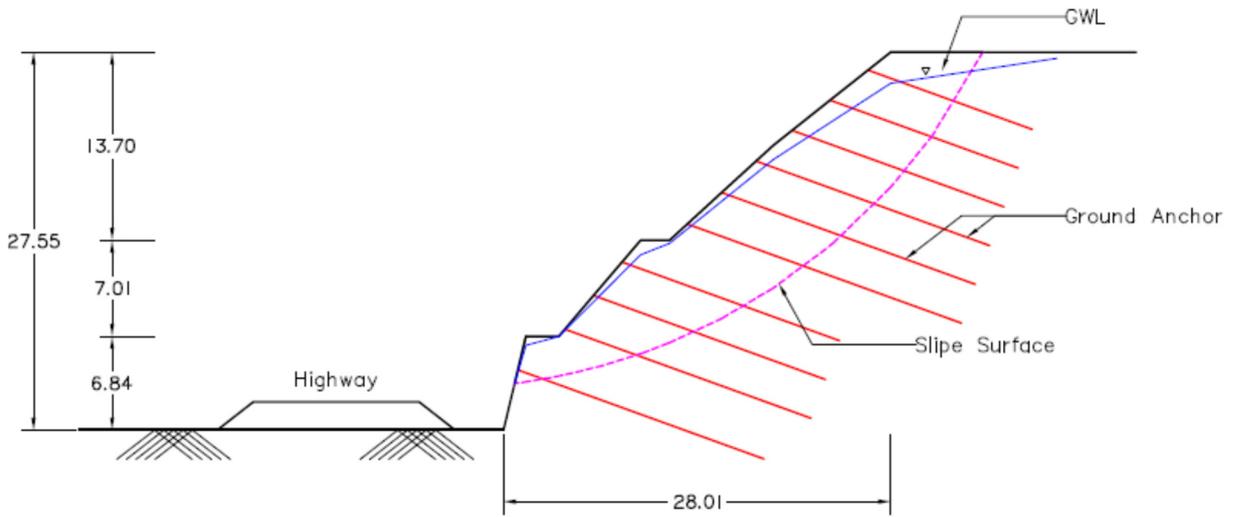
Figure 2.18 The slope configuration for analysis in previous studied (Kimoto et al, 2011)

Figure 2.18 demonstrates a slope configuration for analysis in a previous study by Kimoto et al, 2011. The height of slope is 27m consisting of 2 berms and width of slopes is 26m. Some part of this slope presented the gradient greater than 1:1 in horizontal to vertical which quite dangerous and potential to collapse anytime during monsoon season. Ten ground anchors were installed to increase the stability of slopes; the inclination of each ground anchor is 20°. In addition, ground water level was fixed in the worst case which means that groundwater is reach to near the ground surface.

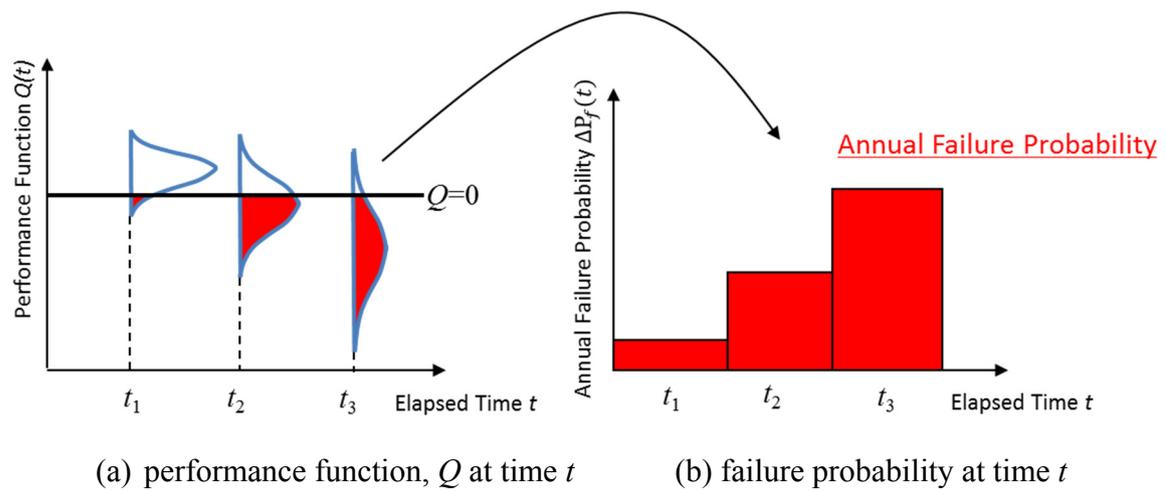
Figure 2.19 Relationship between performance function and failure probability

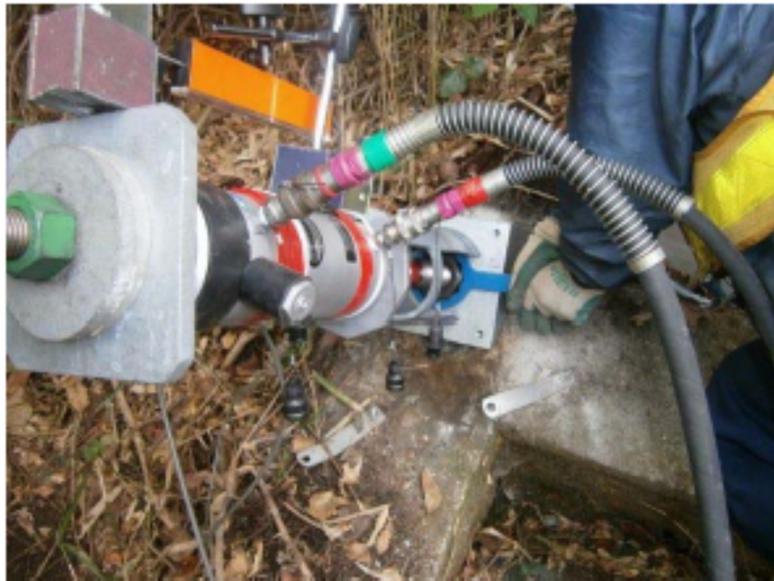
(a) The Lift off test performed by the hydraulic jack

Figure 3.5 demonstrates the example of the Lift off test which conducted by pull-out on the ground anchor head employing loading jack as shown in Figure 3.5 (a) to measure the magnitude of the load in the anchor tendon and displacement. The resultant of load-displacement curves are presented in Fig 3.5 (b), where executed at least twice cyclic tests. The dashed lines are the gradients which represented the tendon stiffness that depending on the definition of measurement such as initial elasticity, tangent elasticity and elasticity at 50% of the yield point. These results can be used to investigate the abnormalities on the tendon or the bonding portion of the anchor. Moreover, it can be used to judge the need for

investigating the back of anchor heads, conducting maintenance tests and re-stressing or prolonging the life span (Miyatake et al, 2007).

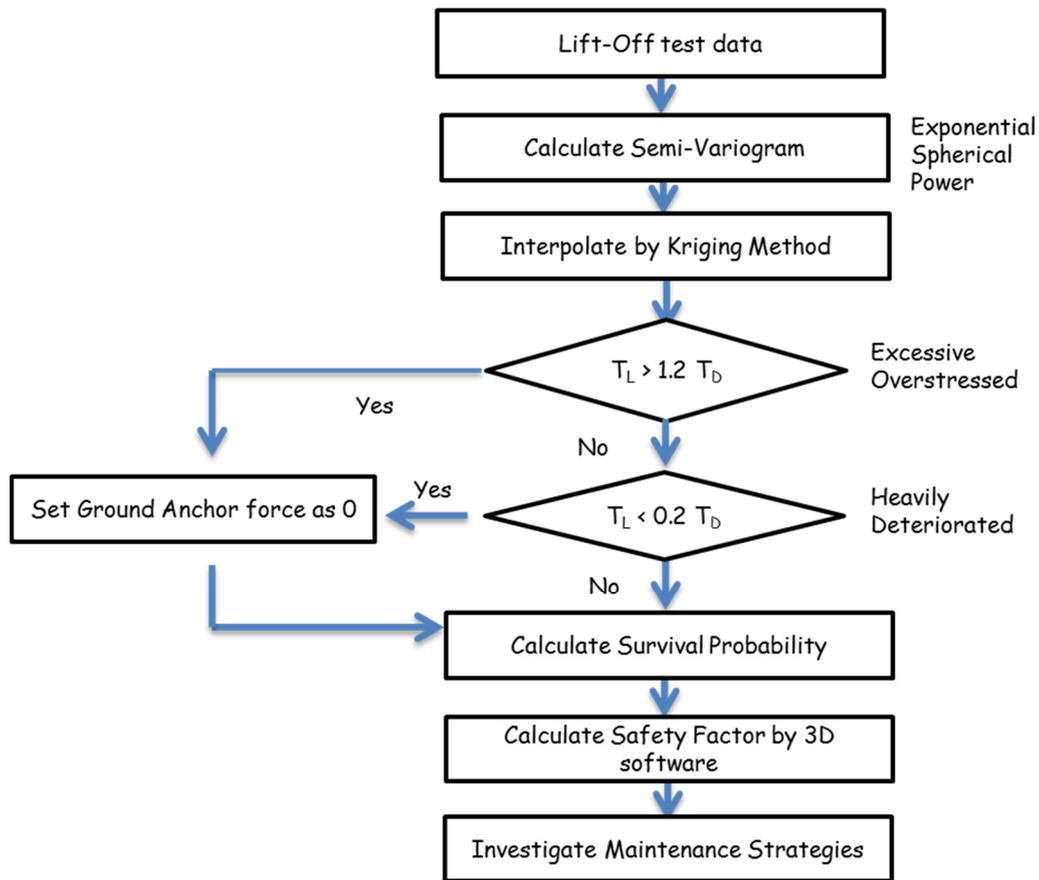
Figure 3.7 Flow chart of Lift off test results

Figure 3.7 demonstrates the flow chart to analyze the present condition of the Lift off test results. The first phase is to interpolate the unknown ground anchor force nearby the testing spots employed the advance geo-statistic technique call kriging method. The semi-variogram was calculated to investigate the appropriate model to simulate the kriging, for example, Spherical, Exponential and Power models. Then evaluate the unknown force and classify all results, whether failure or not associated with the flow chart mentioned above.

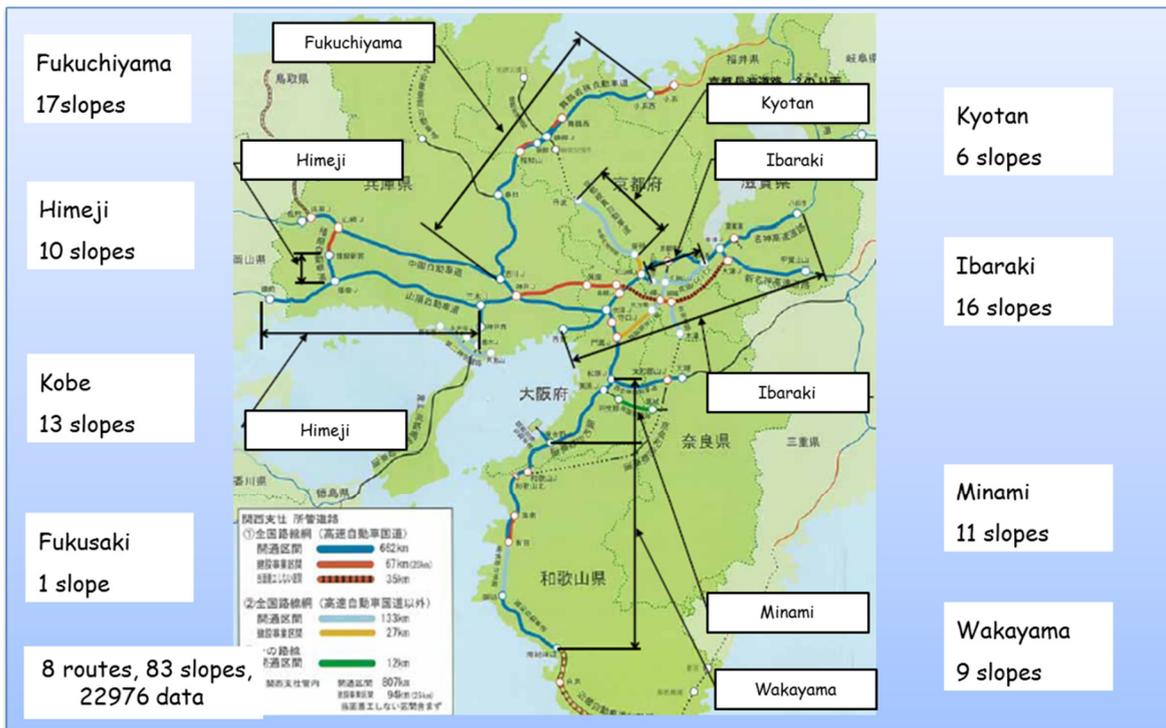
Figure 4.1 Routes and number of testing slopes obtained from the Visual inspection test

This study was conducted on slope reinforced by ground anchors along the expressways in the Kinki district, including Kyoto, Osaka, Kobe and Himeji prefectures. The Visual inspection test results obtained from those areas consisting of eight routes, 83 slopes, comprised of 17 slopes in Fukuchiyama, 10 slopes in Himeji, 13 slopes in Kobe, 1 slope in Fukusaki, 6 slopes in Kyotan, 16 slopes in Ibaraki, 11 slopes in Minami and 9 slopes in Wakayama. The total number of testing is 22,976 data set as presented in Fig 4.1.

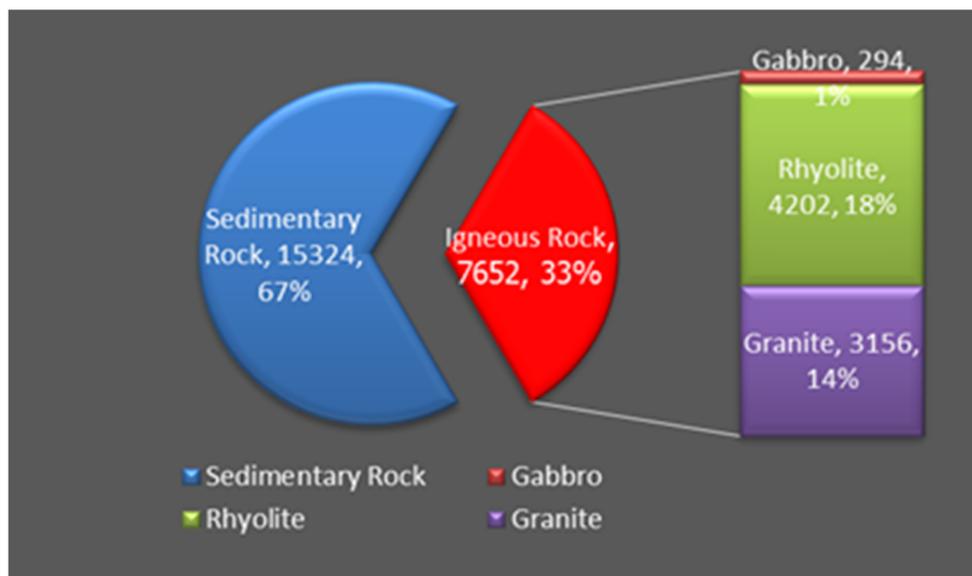
Figure 4.2 Comparison number of samples among of different geological conditions

The number of samples was compared among of different geological condition, including sedimentary, gabbro, rhyolite and granite rock as presented in Fig 4.2. They were installed in sedimentary rock about two third of whole data set, which is the largest group, on the other hand, they were installed in gabbro rock just one percent. Moreover, rhyolite and granite shared only 18% and 14%, respectively. It might be an inadequate sample to analysis the deterioration process if considers individually, therefore, gabbro, rhyolite and granite were regrouped as the igneous rock. Finally, the ground anchors installed in the igneous rock was found 33% that about one-third of total inspected data.

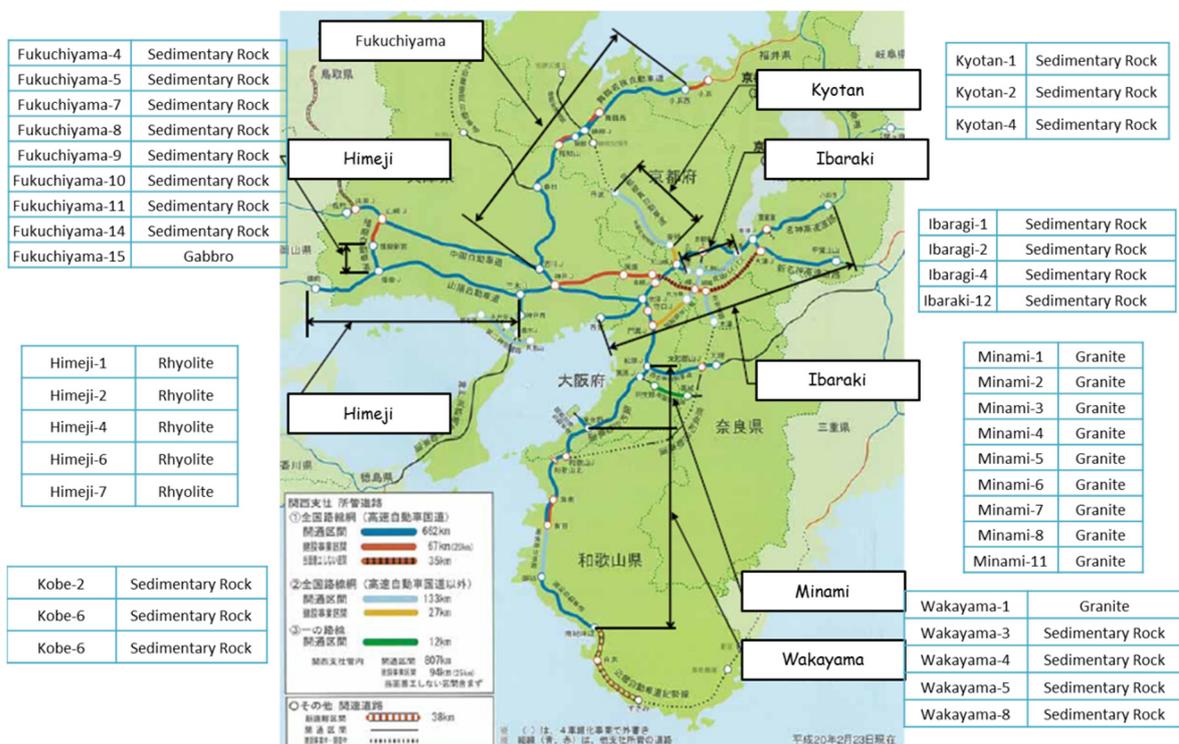
Figure 4.7 Routes and data of the Lift off test obtained from field test

Four geological conditions were grouped, which are sedimentary, gabbro, rhyolite and granite rock types which are same with the Visual inspection test. Therefore, for convenient to analysis, there were re-categorized to be two rock groups, which are sedimentary and igneous rocks. Moreover, the ground anchors were compared by divided into two types, which are rod and strand types because it cannot separately analyze between new and old type of ground anchors due to inadequate data.

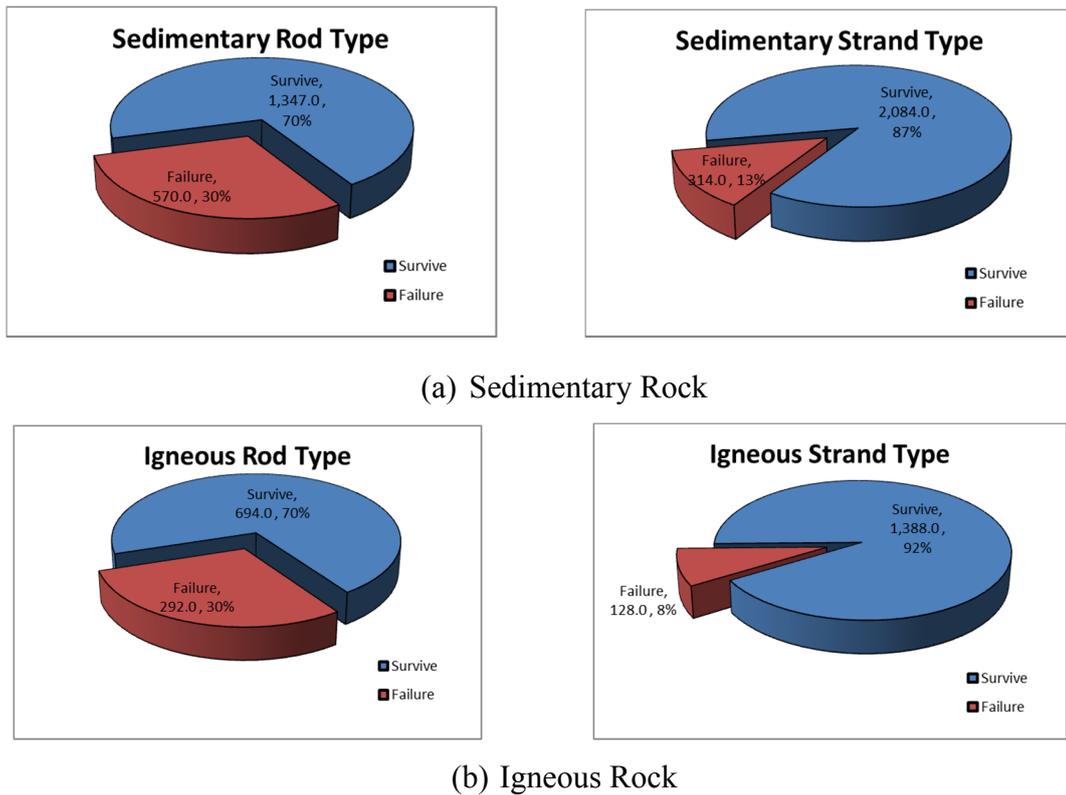
Figure 4.16 The percentages of failures and survives ground anchors of the sedimentary and igneous rock

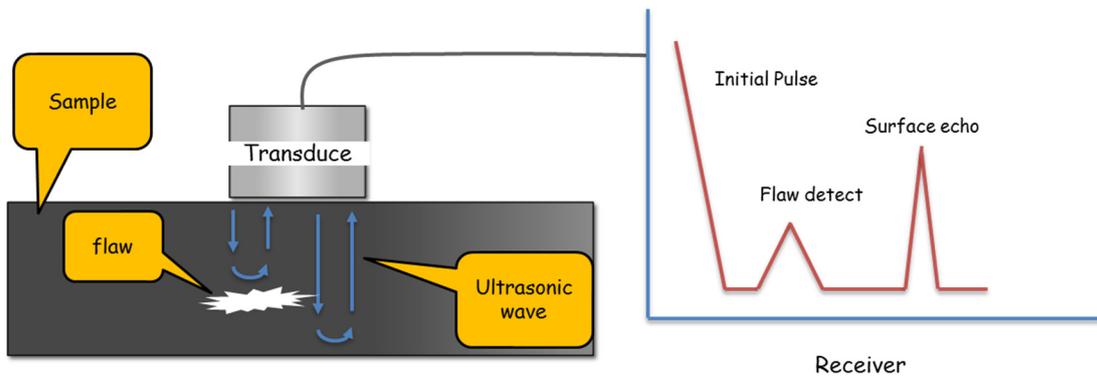
Figure 4.17 The basic concept of the Ultrasonic test

material, good contact with the material is necessary, cannot take a measurement over rust and interpretation needs experience.

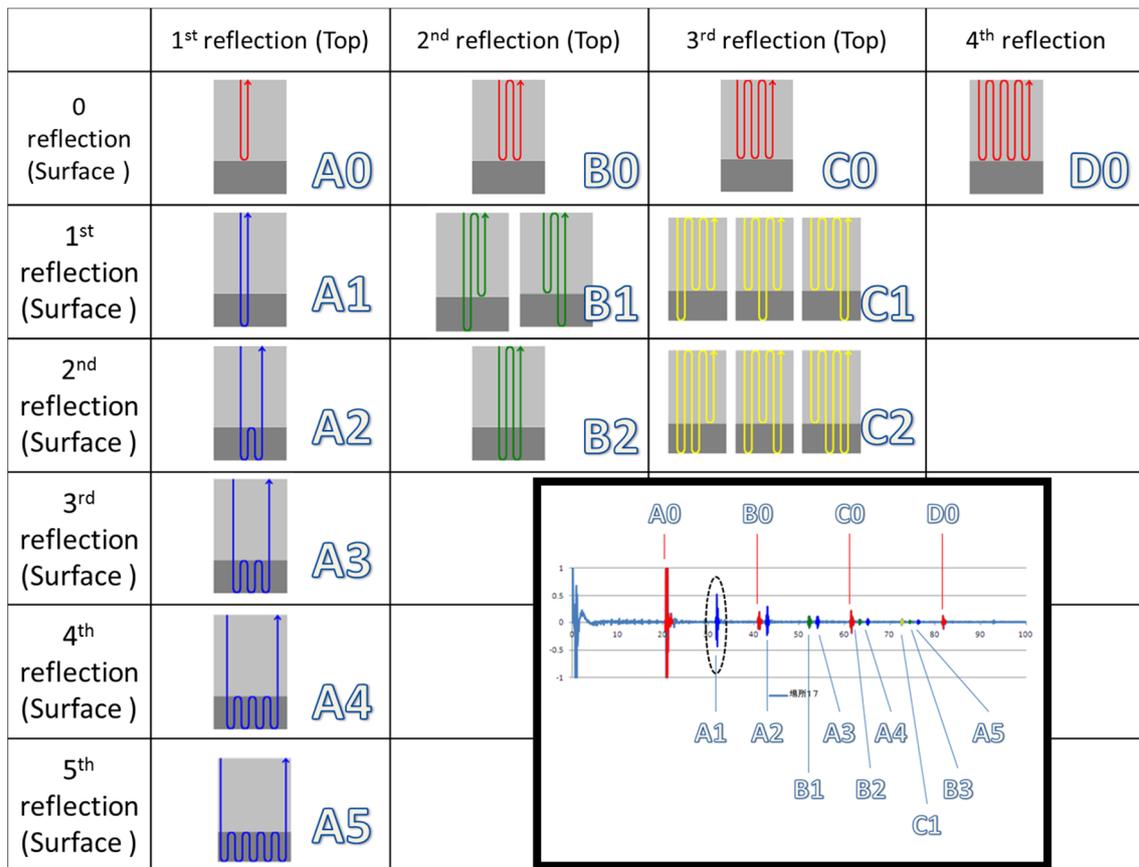
Figure 4.20 The reflection characteristics of Ultrasonic wave

Ultrasonic testing is generally referred as an acoustic wave propagated into material from the transducer and reflected back to the receivers to be detected the discontinuities, composition of layers, defect in a material, thickness and so on. Its results can be demonstrated by acoustic reflection versus time-varying. Many different patterns of vibrational motion are shown in Fig 4.20; depending on changing of their materials or layers.

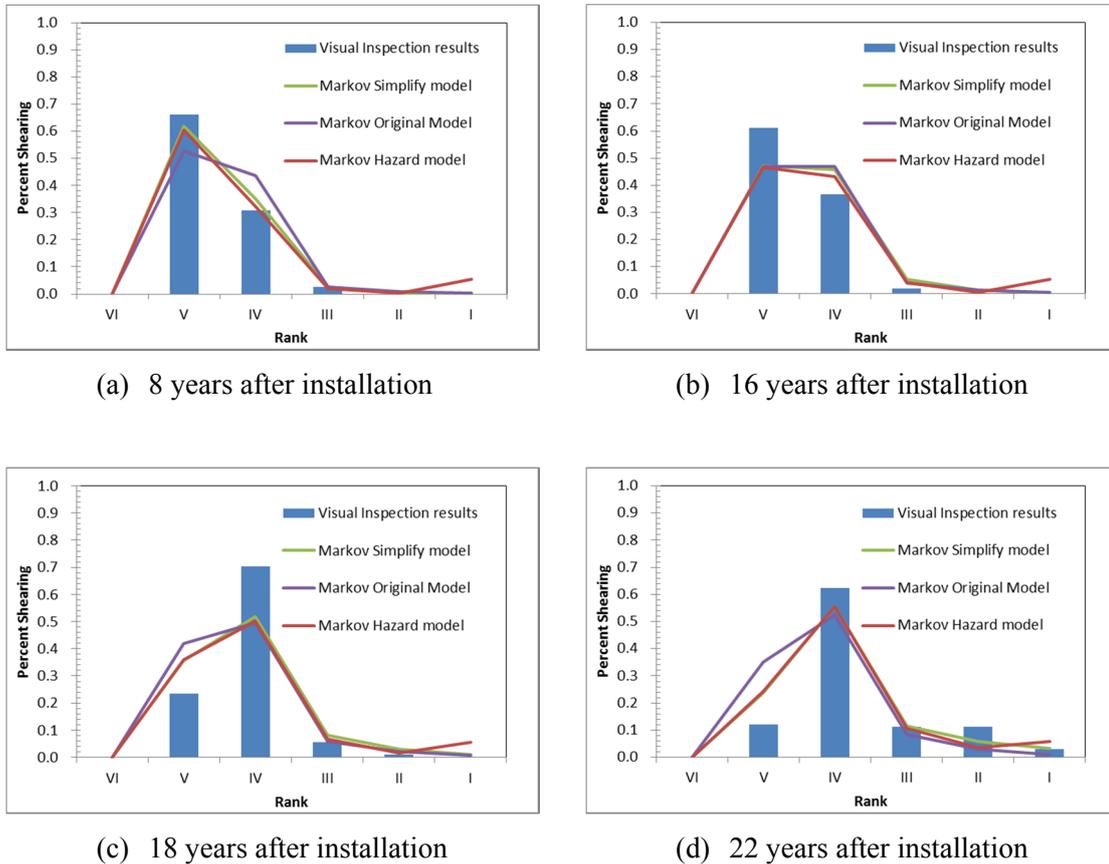
Figure 5.1 Comparison of results among of Markov models with observation data at (a) 8 years (b) 26 years (c) 18 years and (d) 22 years

monitoring meaning that this model is appropriate for predicting the deterioration path. Furthermore, this model showed a more pessimistic scenario than others in the long term. Therefore, we decided to apply the Markov simplify method as the representative of Markov models in this paper.

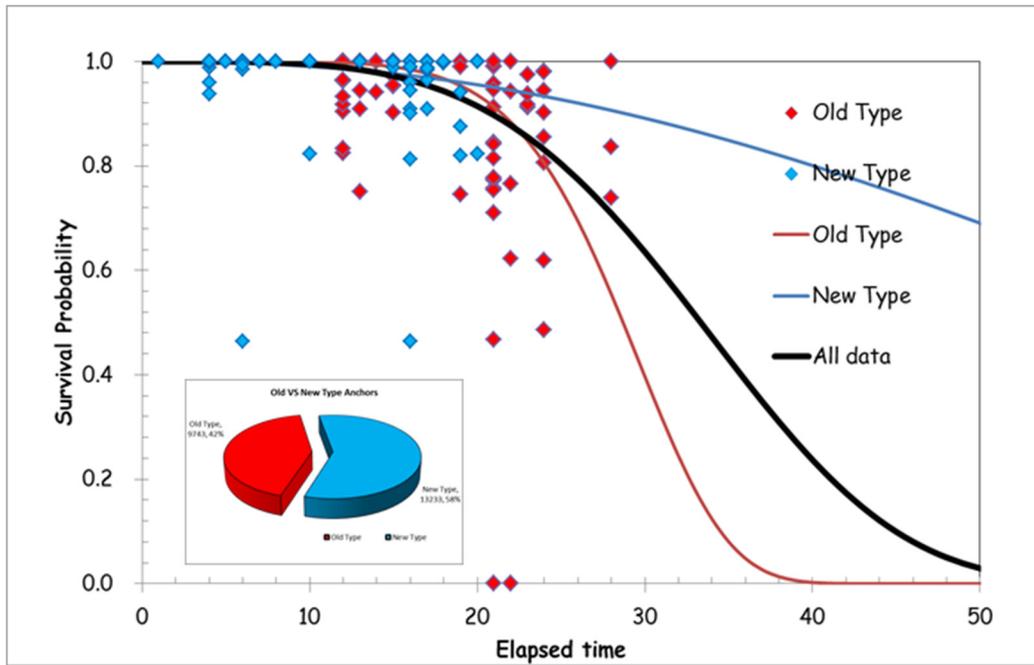
Figure 5.5 Comparison of survival probability among of new type, old type and all data

The simulated results based on the Weibull hazard model were plotted to compare the life span of ground anchor based on the different rusting protections which are new type and old type as presented in Fig 5.5. The new type ground anchors were installed 60%, approximately while the old types were about 40%. The inspection data showed that the new type anchors were tested since the first year after installing whereas the rod type anchors were inspected after twelve years passed.

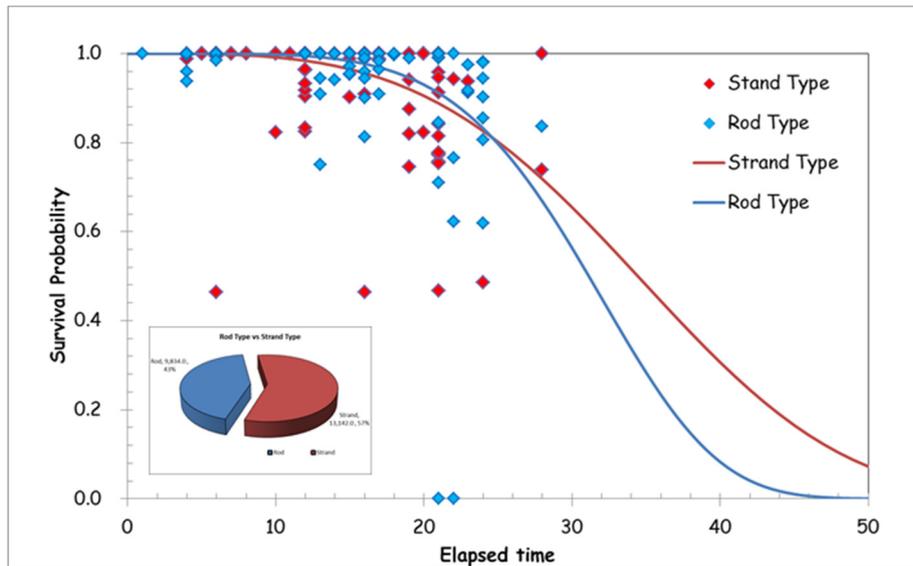
Figure 5.6 Comparison results between rod and strand types

strand type. In addition, some slopes of rod type showed completely failure after 21 and 22 years; nevertheless, the minimum failure probabilities of strand type were only about 50%.

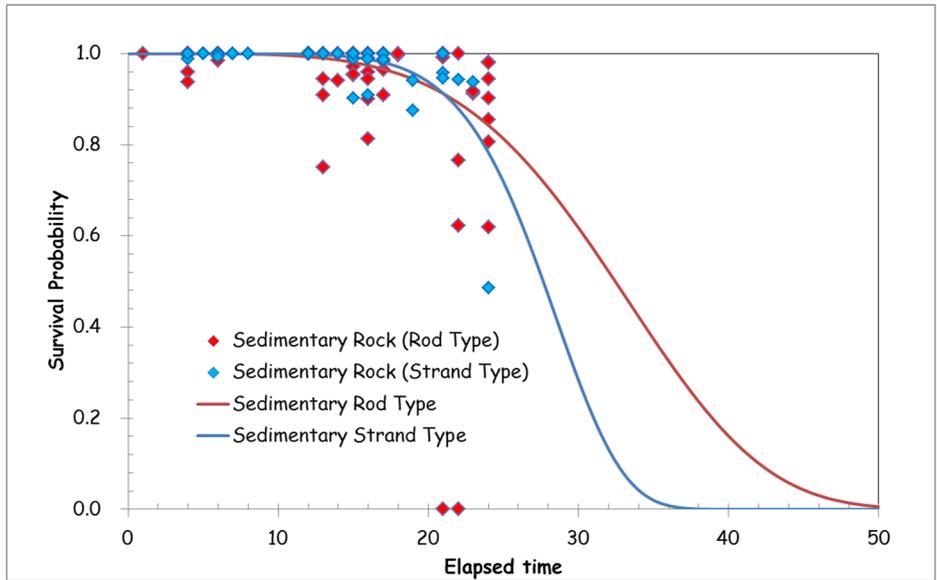
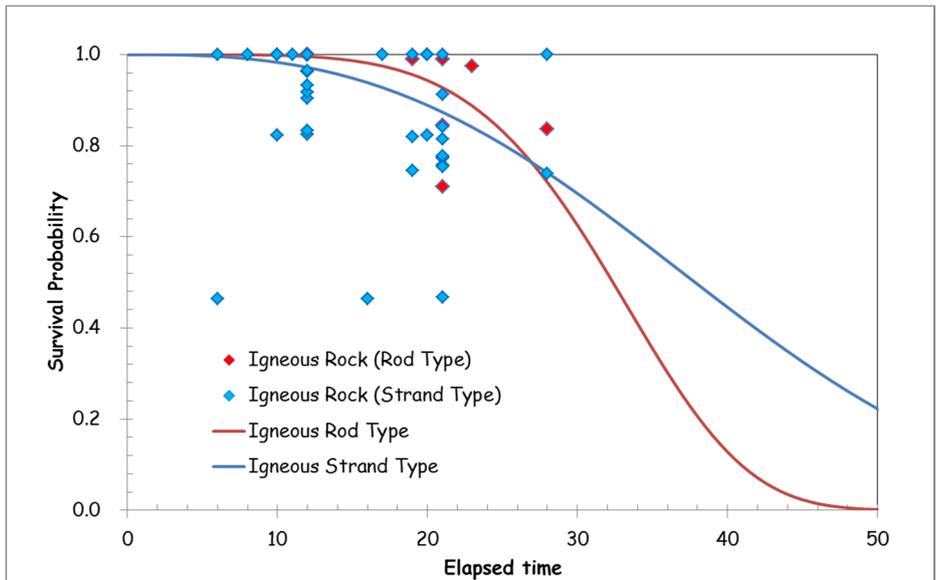
(a) Sedimentary rock

(b) Igneous rock

Figure 5.7 shows the comparison results between rod and strand types considering the different geological conditions which are sedimentary rock (see Fig 5.7 (a)) and igneous rock (see Fig 5.7 (b)), respectively. The scatter points represented survival probability calculated from each slope obtained from the Visual inspection test while the continuous line is the simulated results based on the Weibull hazard model. However, both results showed diverged trends that life span of rod type was shorter than the strand type in the case of the igneous rock while the results of the sedimentary rock indicated opposite outcome. These consequences showed completely the conflict with the previous results that strand type should be longer life span than rod type.

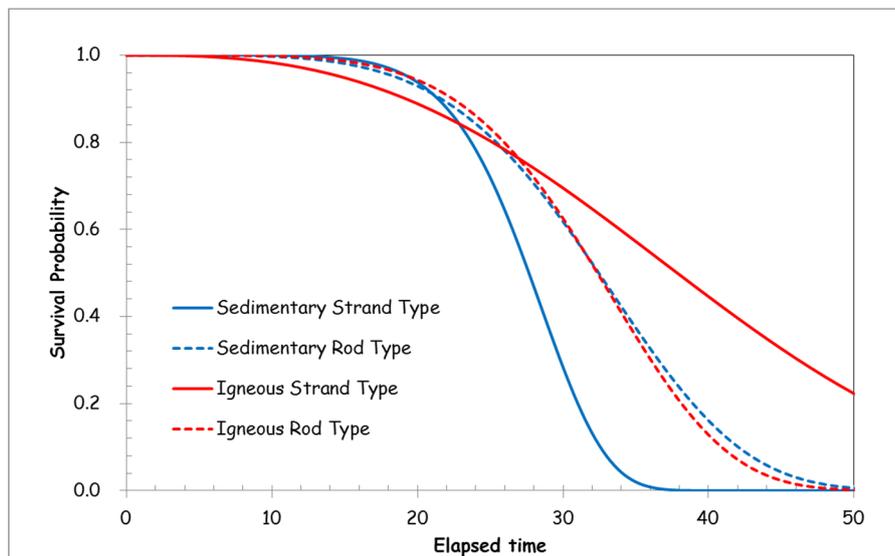
Figure 5.8 Comparison of survival probability between different geological conditions as well as strand and rod types

Moreover, in case of the igneous rock, the rod type showed shorter life span than the strand type, quite similar to previous results as shown in Fig 5.6, whereas the sedimentary rock showed distinct. However, a number of failure data of the igneous rock - rod types were small points that are only four slopes as well as allowable short inspection time during 18 to 28 years only.

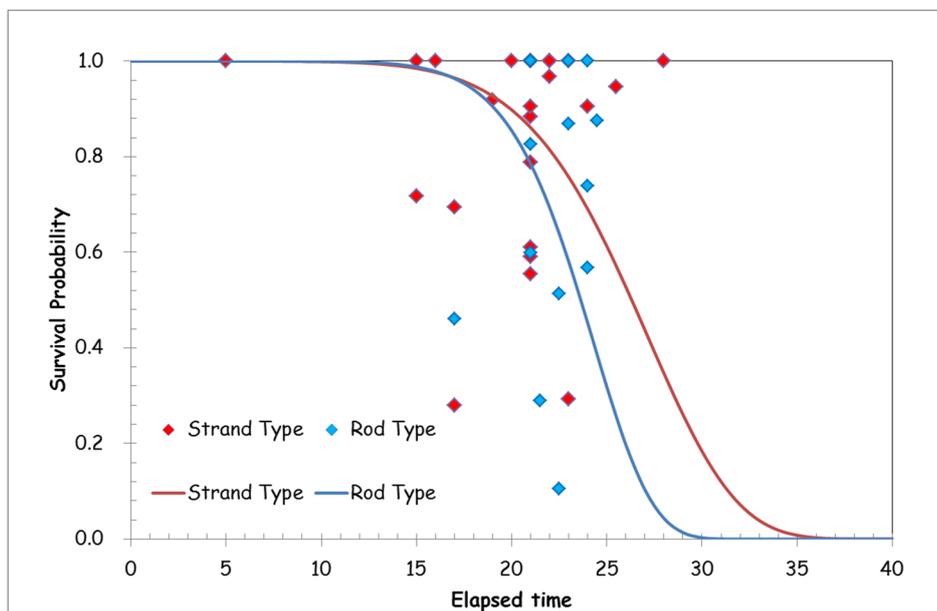
Figure 5.9 Comparison of survival probabilities between rod and strand types.

section. The dwindling rate of the rod and strand types were plotted as illustrated in Fig 5.9. The obtained data were plotted as scattered dot while the simulated results were presented by continuous lines, blue and red color corresponding to rod type and strand type, respectively. Survival probabilities displayed slowly decayed rated on the early stages; afterward drastically reduced after fifteen years. These results revealed the strand type longer life span that the rod type which consistent with the percentage of failure anchors as mentioned earlier. Both results demonstrated that these slopes might reach to a critical point after thirty to thirty-five years after installation for rod and strand types, respectively. In brief, they will reach to failure points within forty years since reinforced.

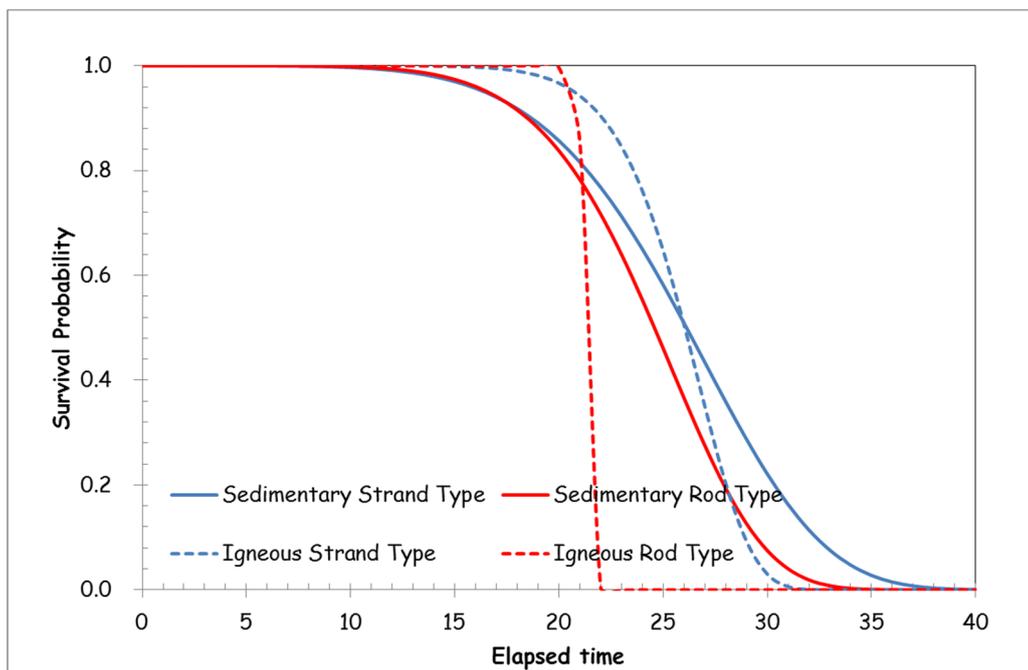
Figure 5.11 Comparison of survival probabilities between different geological conditions as well as strand and rod types

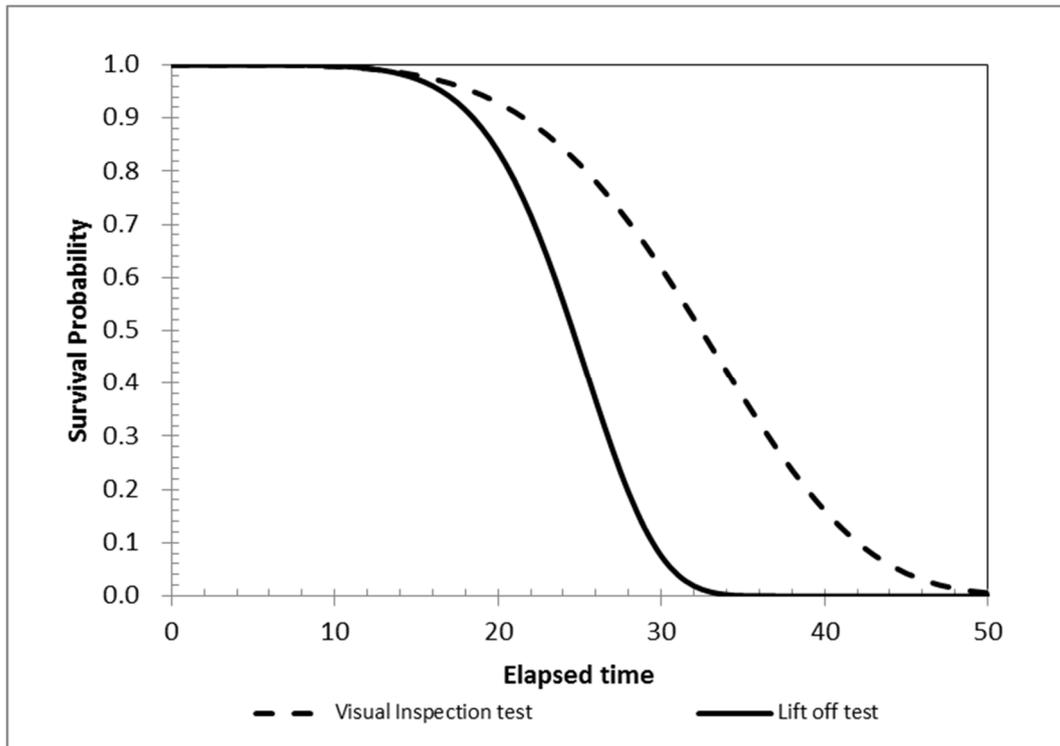
Figure 5.13 Comparison of simulation results between the Visual inspection and Lift off test
