**GEOTECHNICAL INFRASTRUCTURE ASSET
MANAGEMENT FOCUSING ON
PERFORMANCE DETERIORATION PROCESS
OF GROUND ANCHORS**

A thesis submitted in partial fulfillment of the requirements for the
degree of Doctor of Engineering

Department of Urban Management,
Graduate School of Engineering,
Kyoto University
Japan

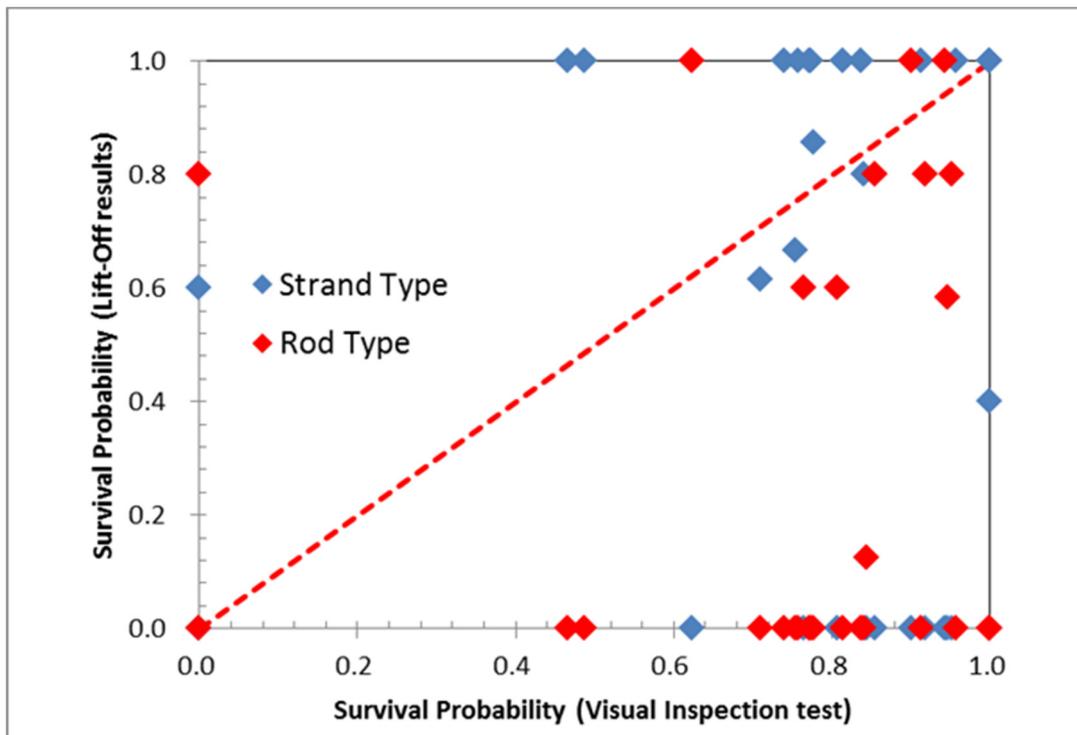
Figure 5.14 Comparison of survival probabilities between the Visual inspection and the Lift off test

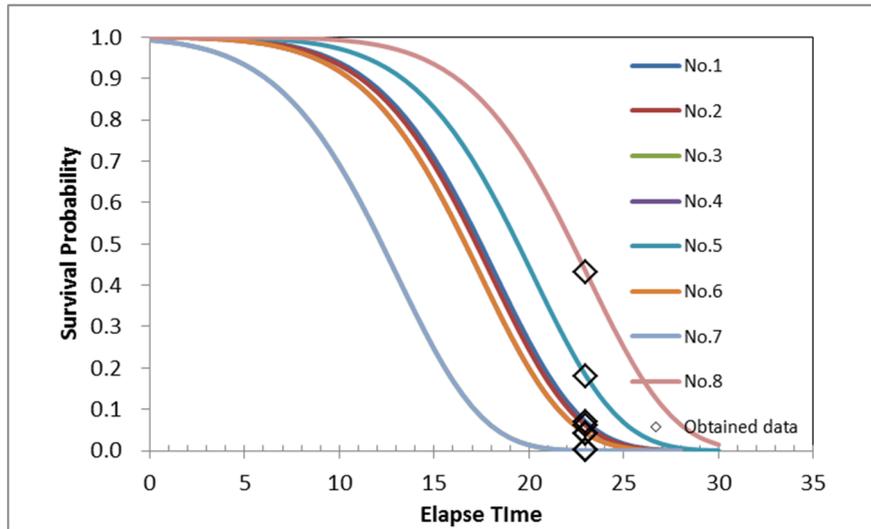
Figure 6.5 The example of deteriorated on anchor force on a slope

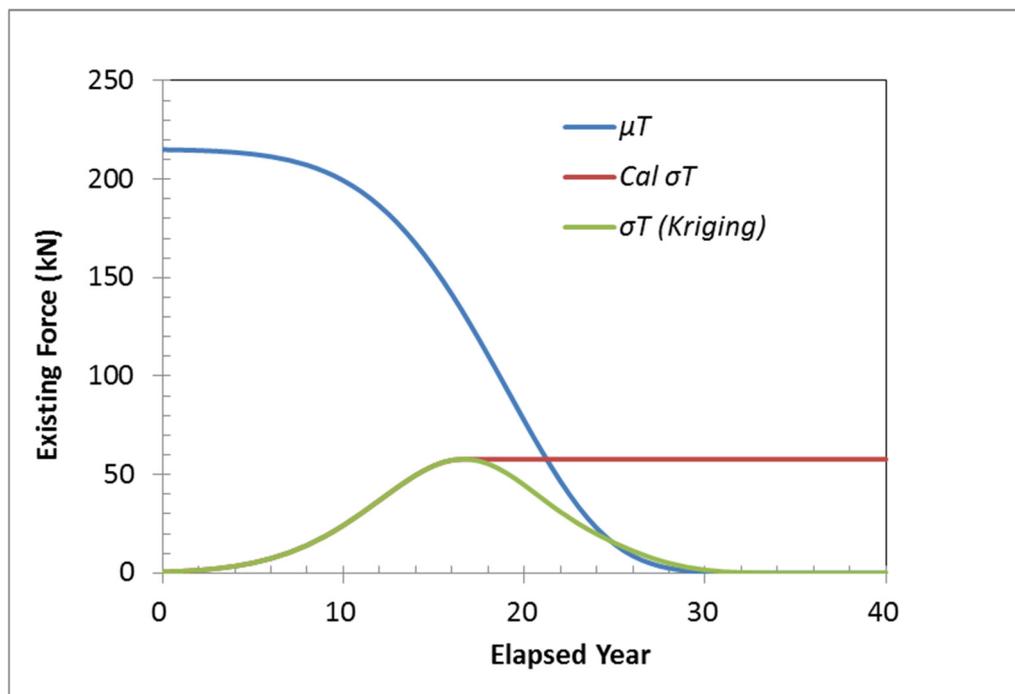
Figure 6.8 The reduction of the existing force with time

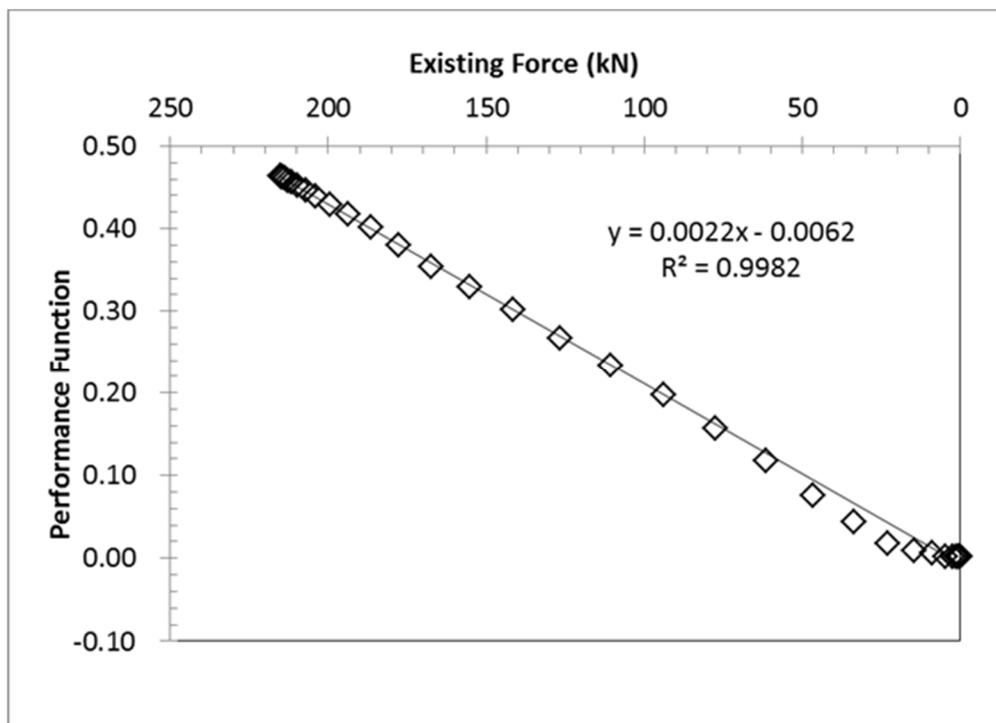
Figure 6.9 Existing forces of ground anchor versus performance function

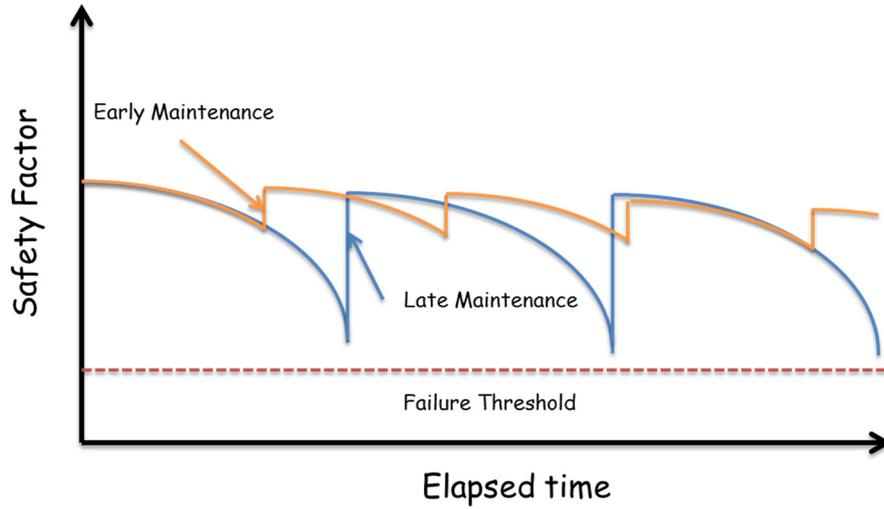
Figure 7.1 Stability of slope improved by ground anchors considering different maintenance strategies

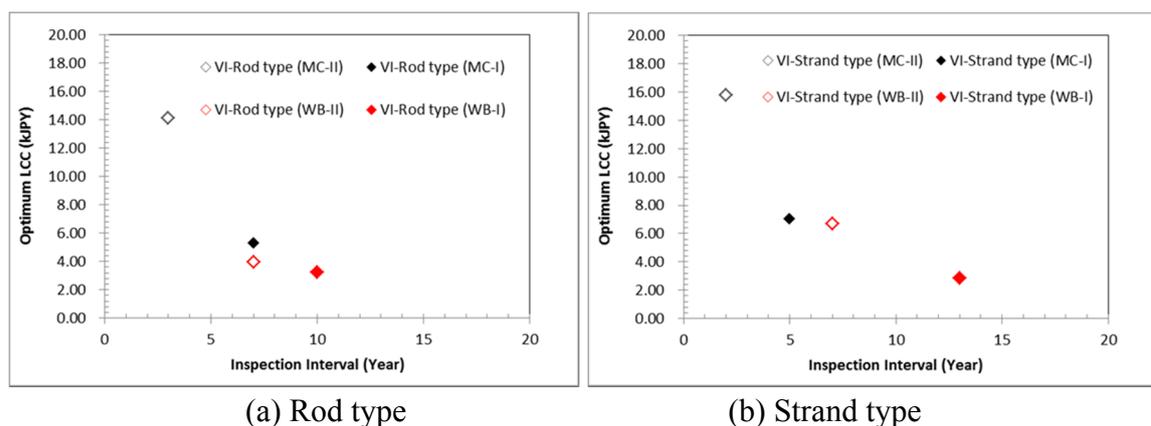
Figure 7.12 Comparison of LCC results between ground anchors type of the Visual inspection test

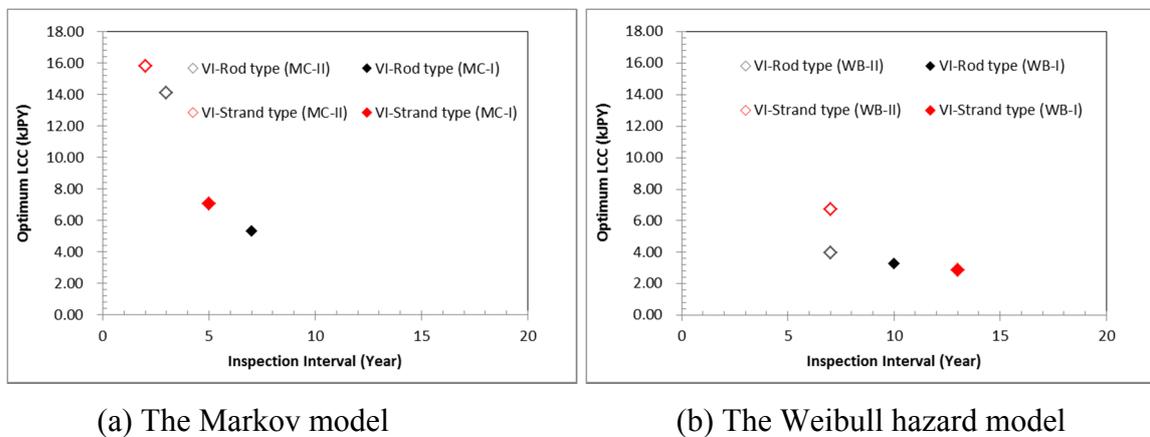
Figure 7.13 Comparison of LCC results between statistical models of the Visual inspection test

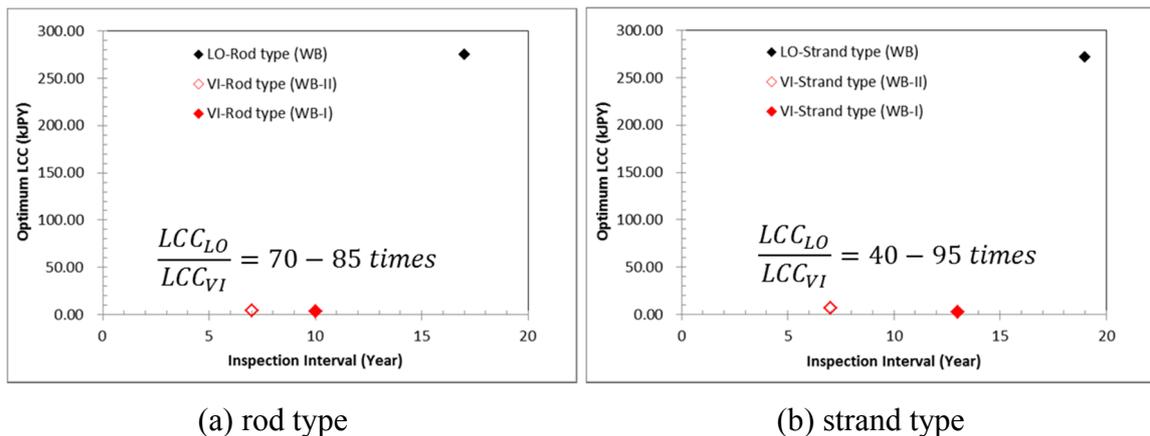
Figure 7.14 Comparison of LCC results between the Visual Inspection test and the Lift off test results

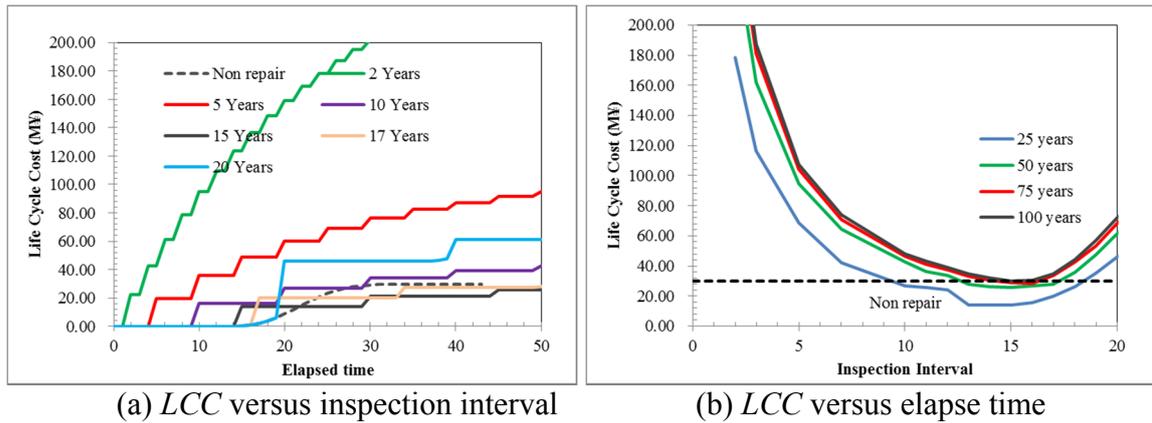
Figure 7.15 Comparison of LCC with difference repair scenarios of Ibaraki No.4

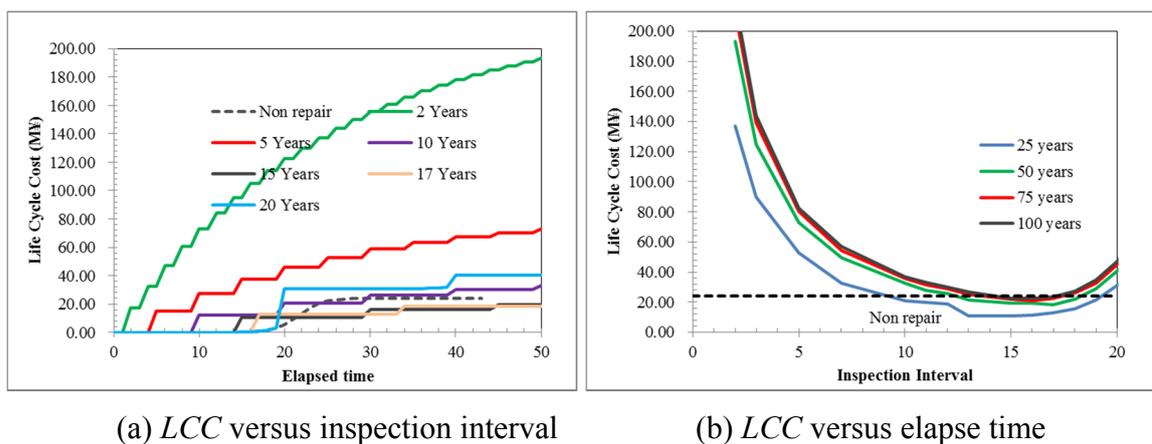
Figure 7.16 Comparison of LCC with difference repair scenarios of Ibaraki No.2

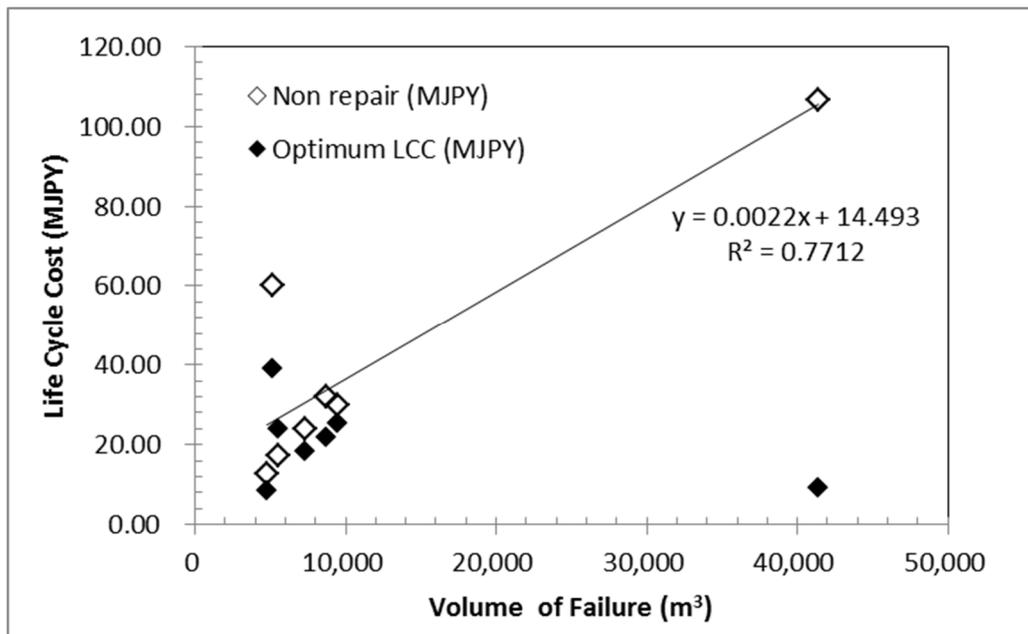
Figure 7.22 *LCC* versus volume of failure of risk slopes

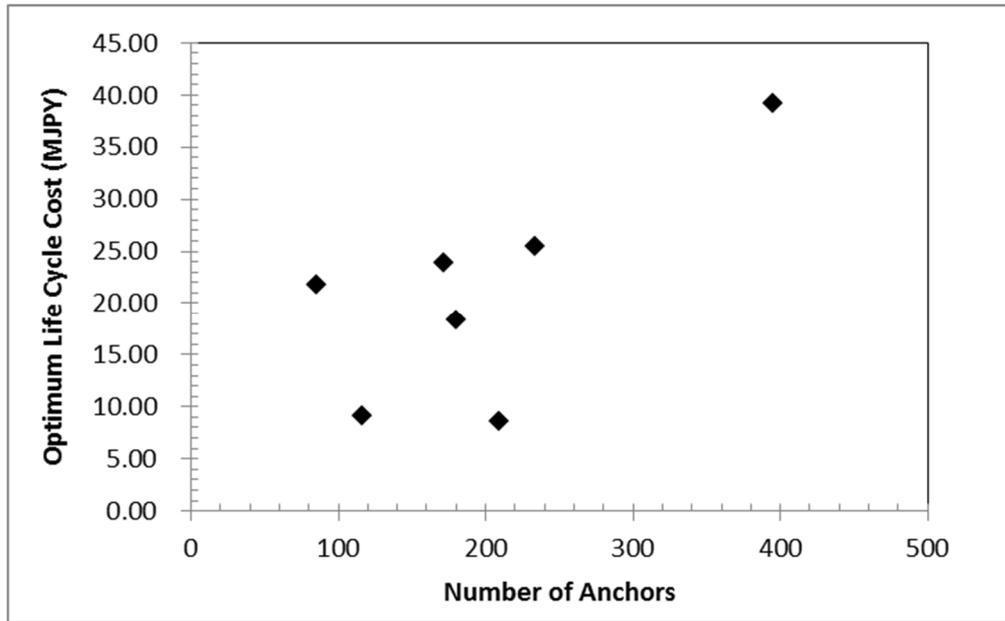
Figure 7.23 Optimum *LCC* versus number of anchors installed
